PRE PURCHASE BUILDING REPORT

Inspection: 15-12-2016

Low set timber clad & Iron roofed dwelling on timber stumps.

Pre-Purchase Building Report

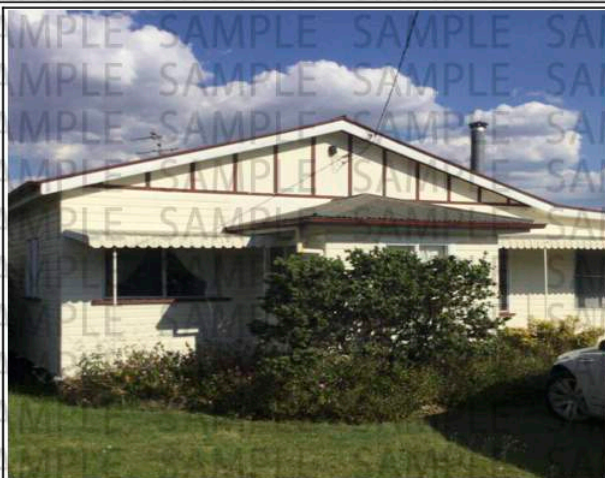
Photo 1 Front LH street view.

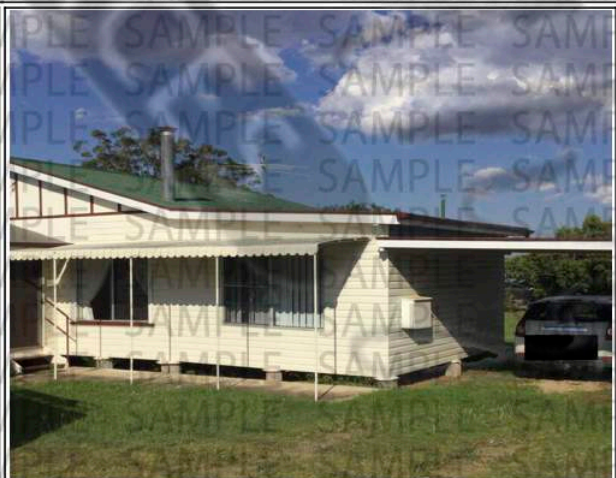
Photo 2 Front RH street view.

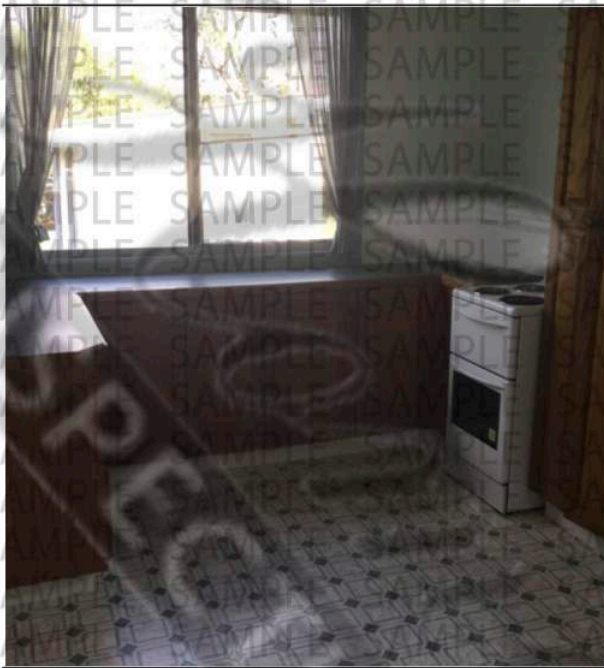
Photo 28 Kitchen in generally good condition.

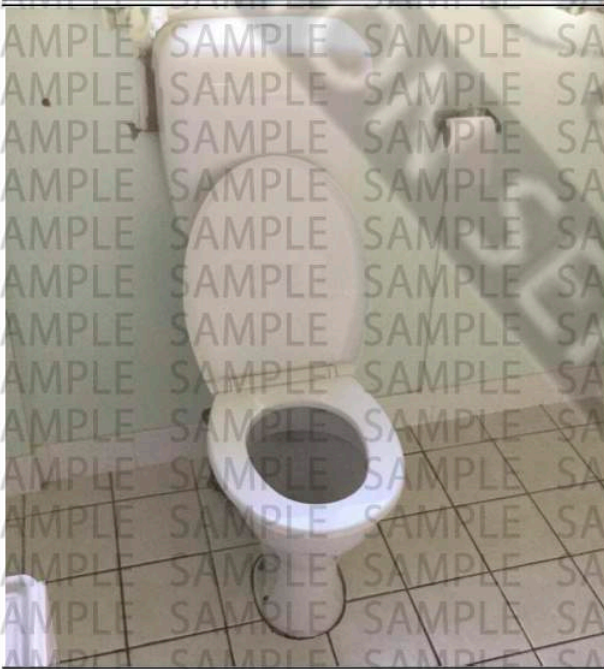
Photo 30 WC in fair condition.

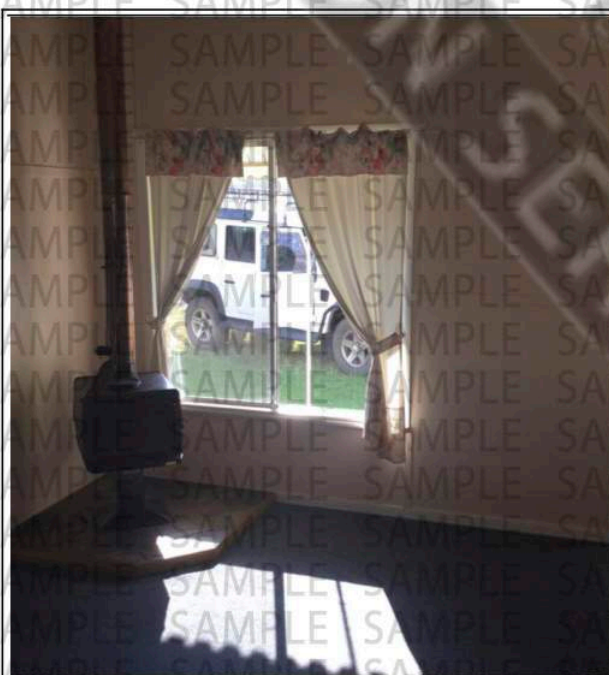
Photo 21 Lounge with fireplace.

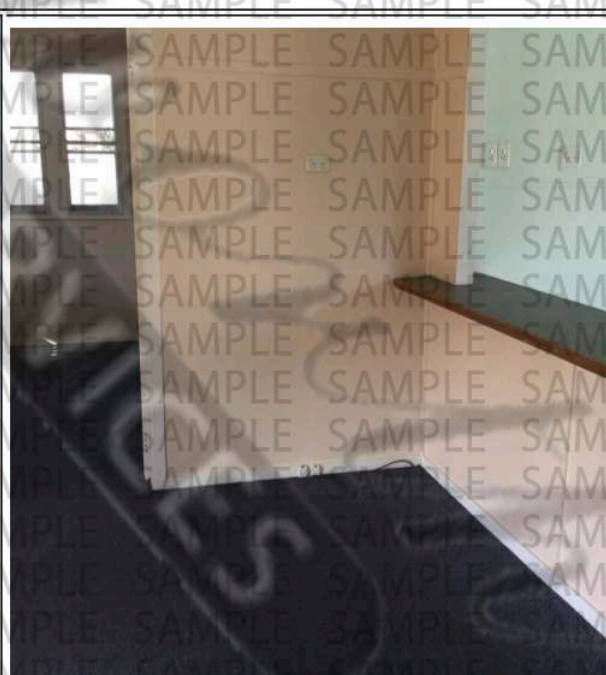
Photo 22 Lounge/ Dining archway

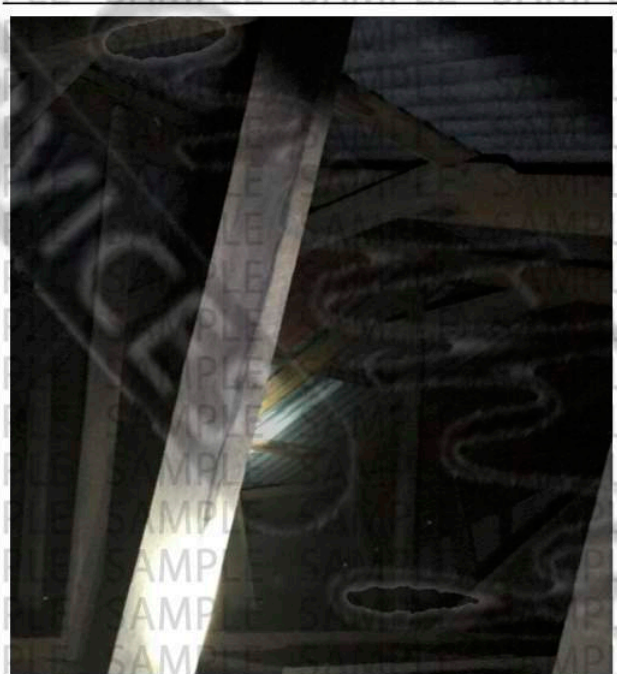
Photo 16 Struts positioned into the internal load bearing wall satisfactorily.

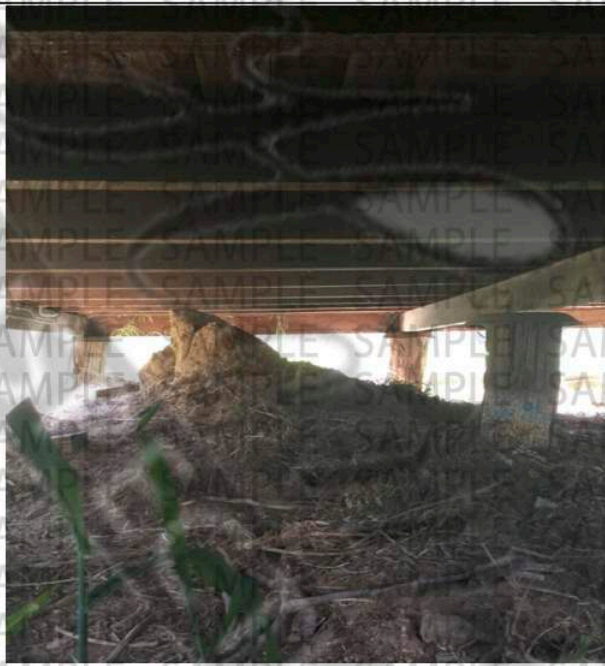
Photo 12 There is a pile of concrete & sand blend piled under the front RH extension. This should be removed away from the floor timbers as it poses a risk for entry by termites.

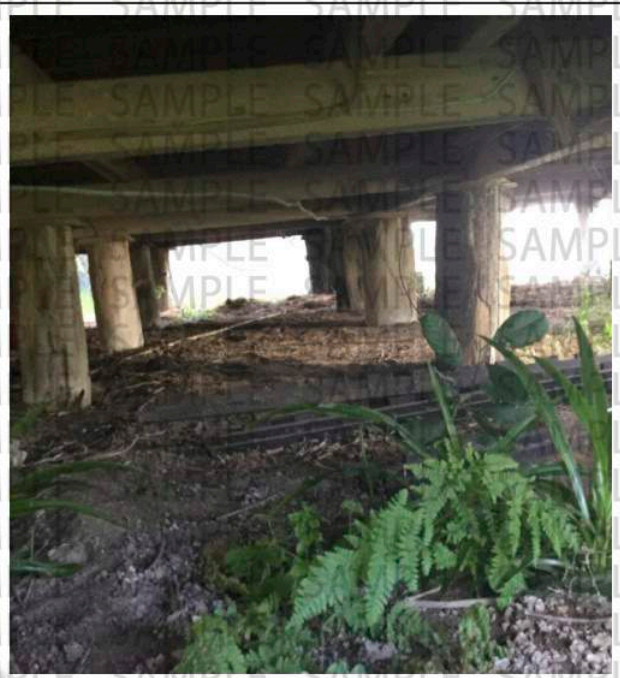
Photo 13 The adjacent timber stump to the gravel pile is not supporting the flooring and as such the extension sunroom floor is bouncing due to the lack of support.

Repack the front internal stump to prevent floor bounce as reported.

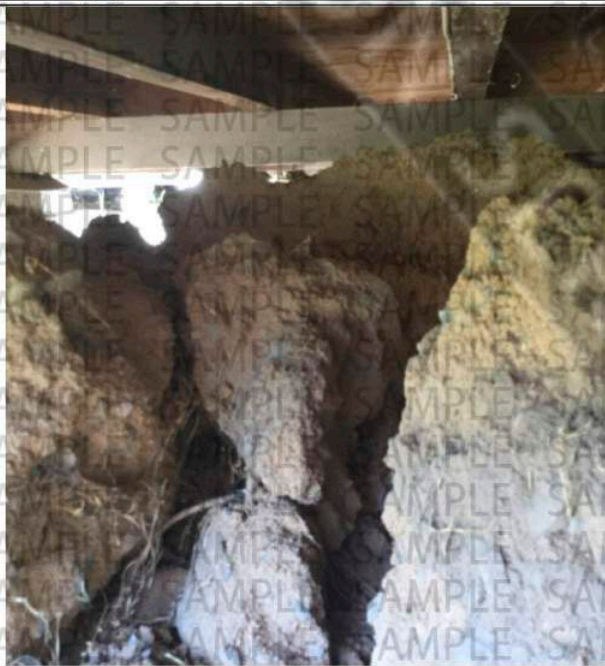
Photo 14 Remove this pile of gravel & sand immediately.

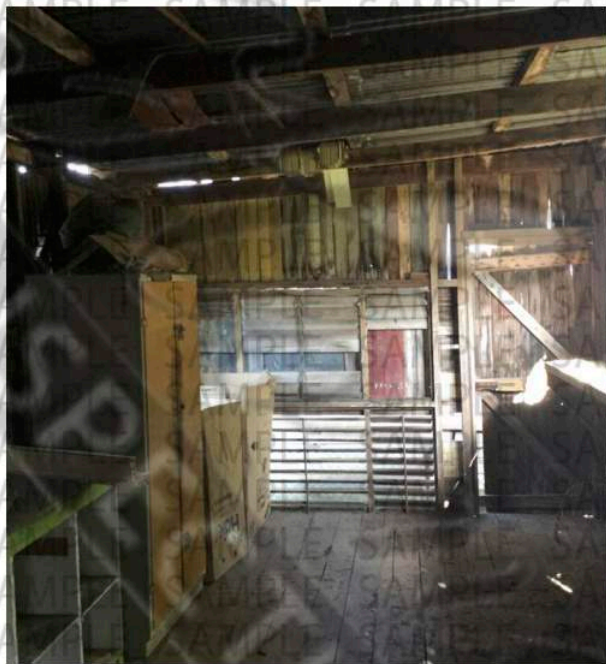
Photo 9 Various repairs required to rear shed beyond economic feasibility.

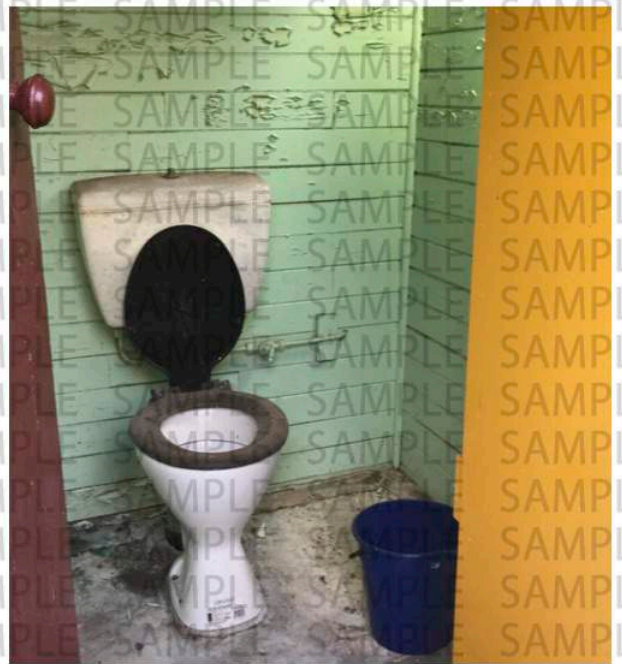
Photo 10 Rear WC installed in outbuilding. Asbestos containing materials.

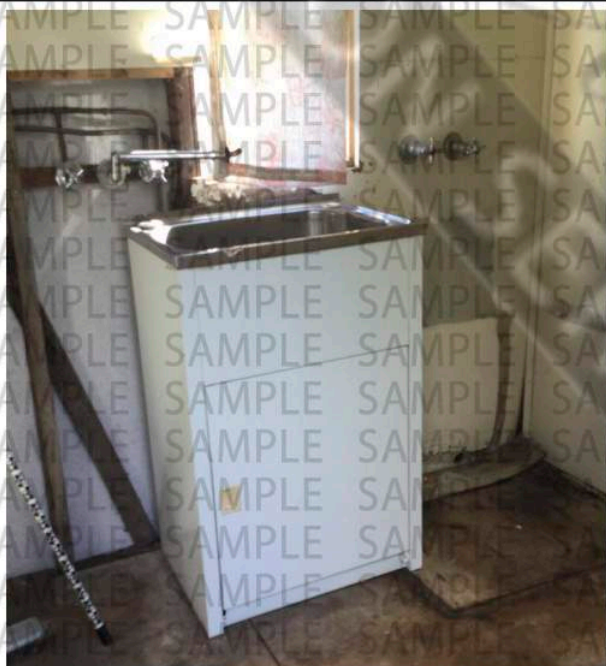
Photo 11 Laundry installed adjacent in outbuilding.

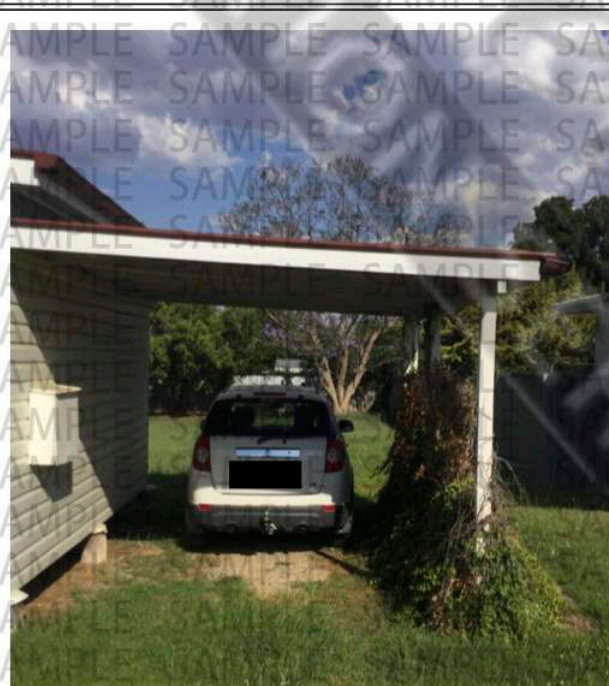
Photo 3 Carport on RH front side.

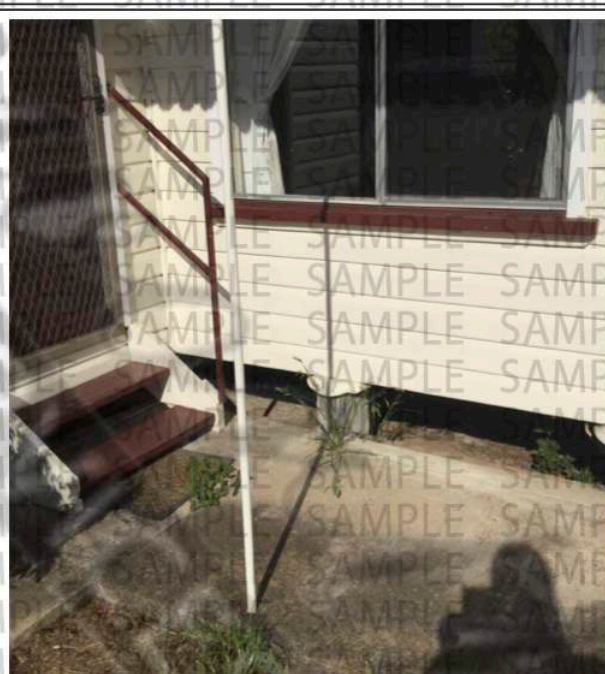
Photo 4 Front entry timber treads.

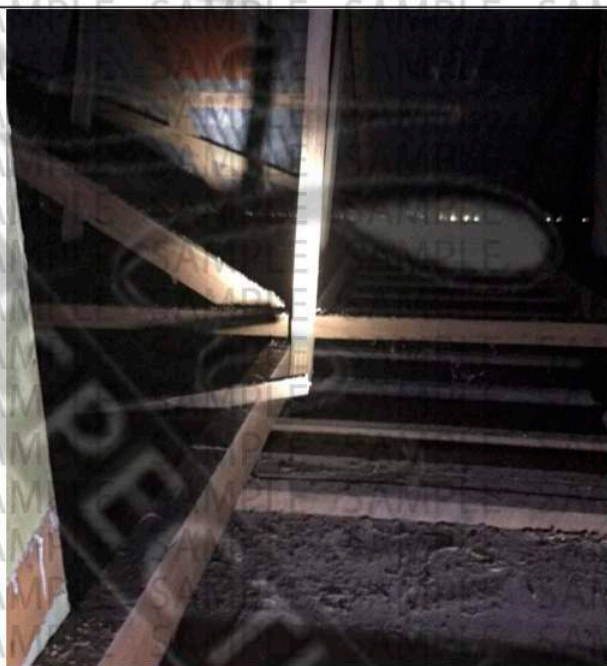
Photo 17 The roof sheeting in some parts has been replaced to arrest some previous leaks. As the roof is in the last of its expected life it is recommended that this be replaced in the medium term.
