## RESIDENTIAL DILAPIDATION REPORT

CLIENT: Flametrees Tourist Village

2955 Shute Harbour Drive Airlie Beach QLD 4802

Detail damage following TC Debbie

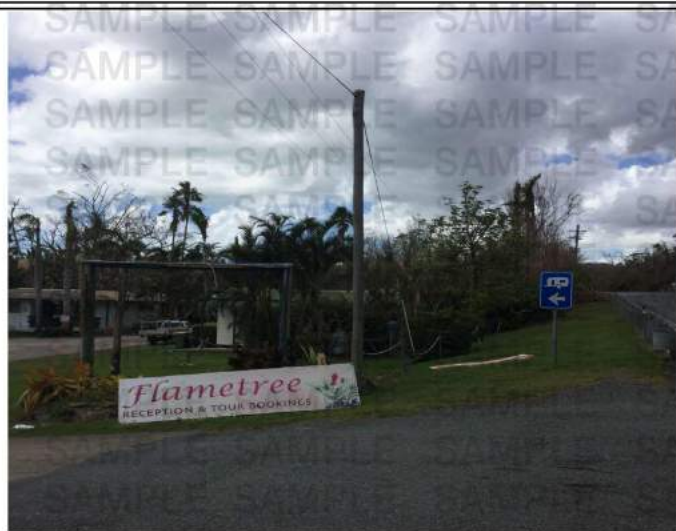
Photo 1 Street view from LH front corner.

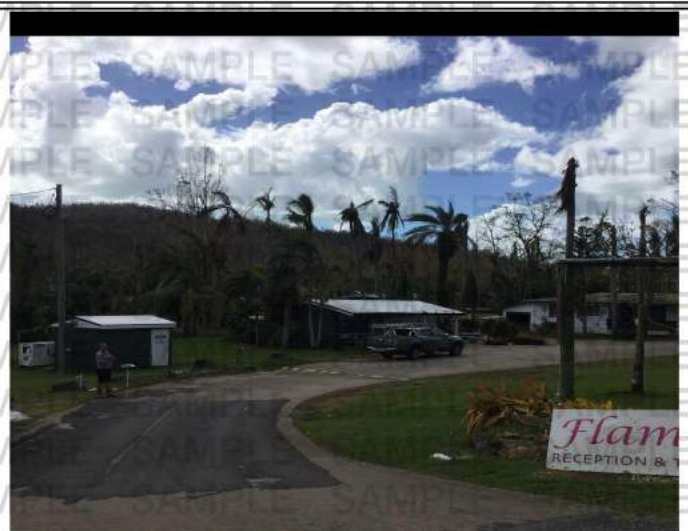
Photo 2 Generally park consists of camping grounds, Self contained duplex cabins & ancillary structures.

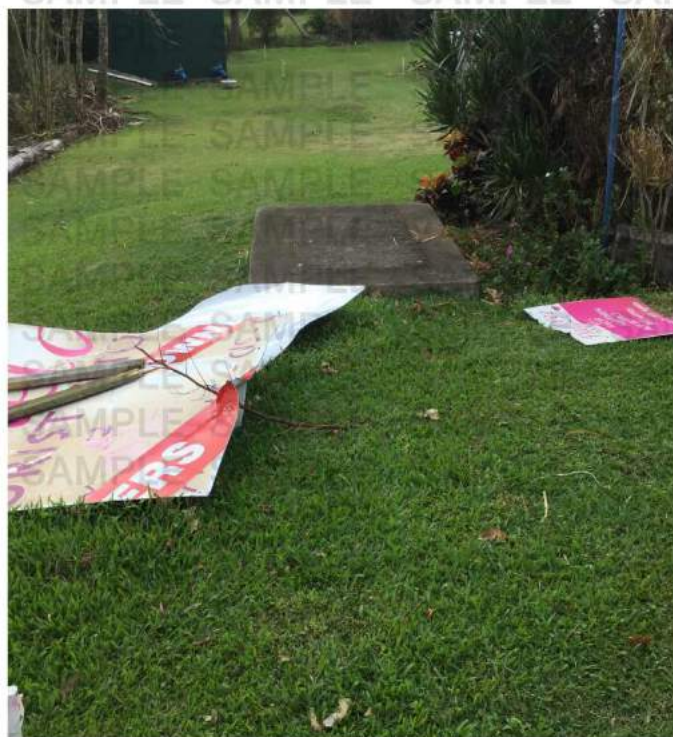
Photo 3 Front signage damaged

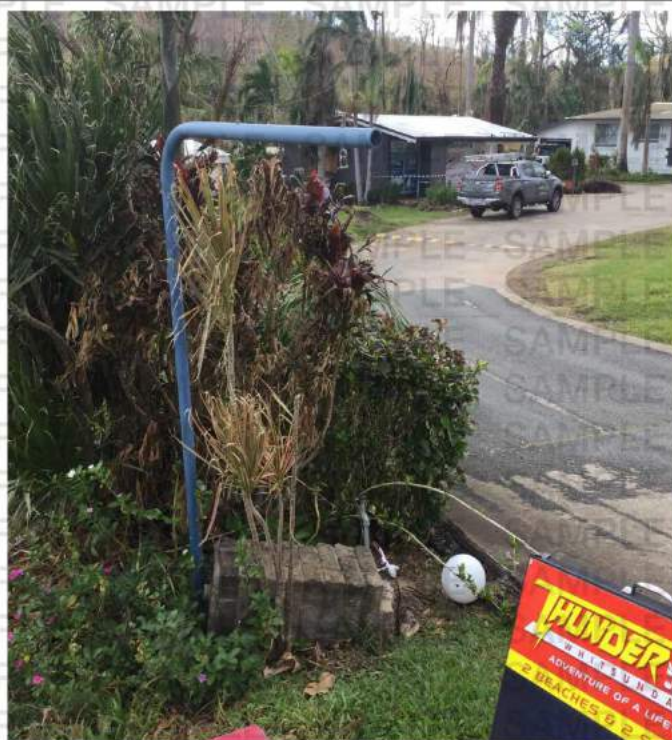
Photo 4 Brick support pier damage LH side of driveway.

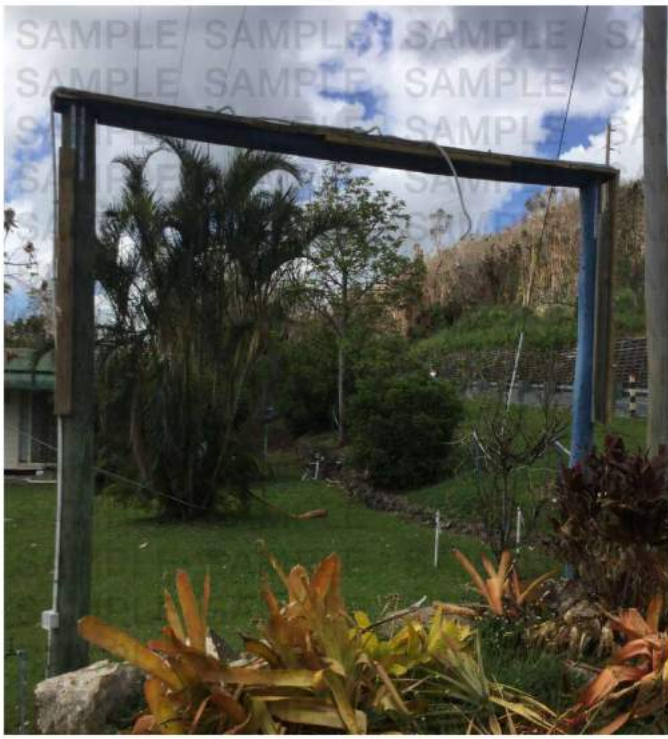
Photo 5 Main signage damage RH side of park entry.

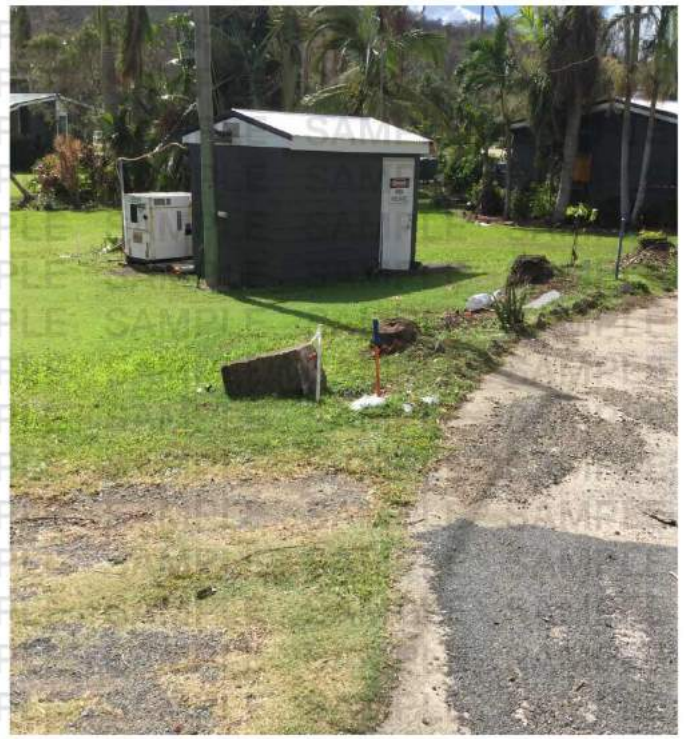
Photo 6 Front lighting plinth damage. Electrical made safe.

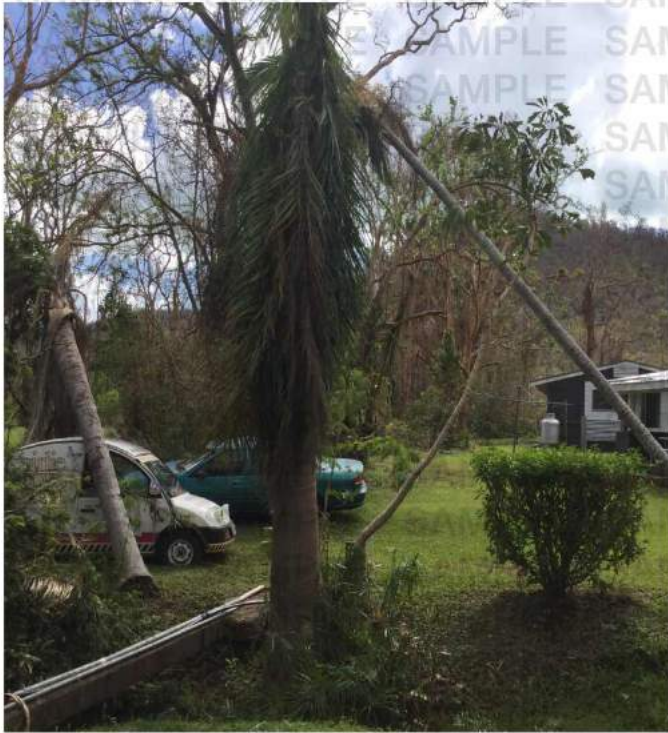
Photo 7 Various tree damage made safe.

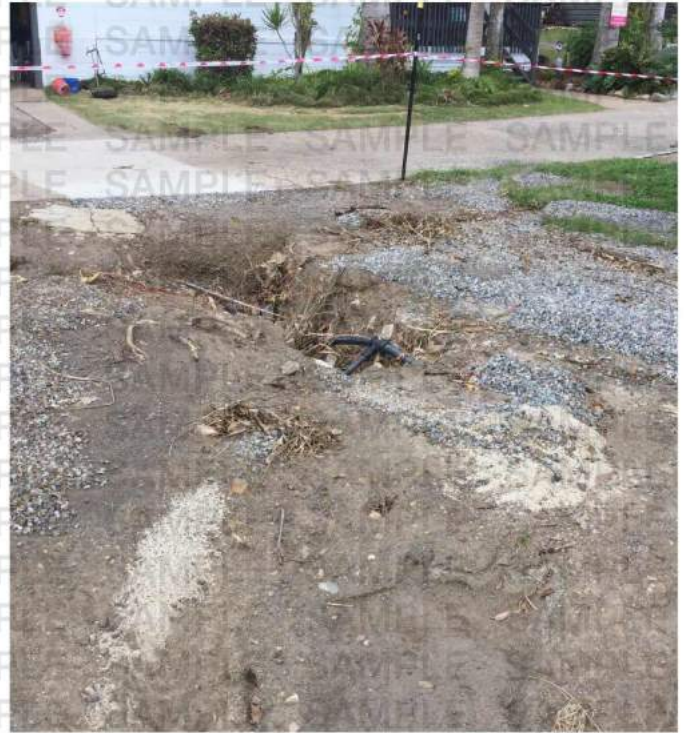
Photo 8 Erosion of driveway to Office. Considered landscaping.

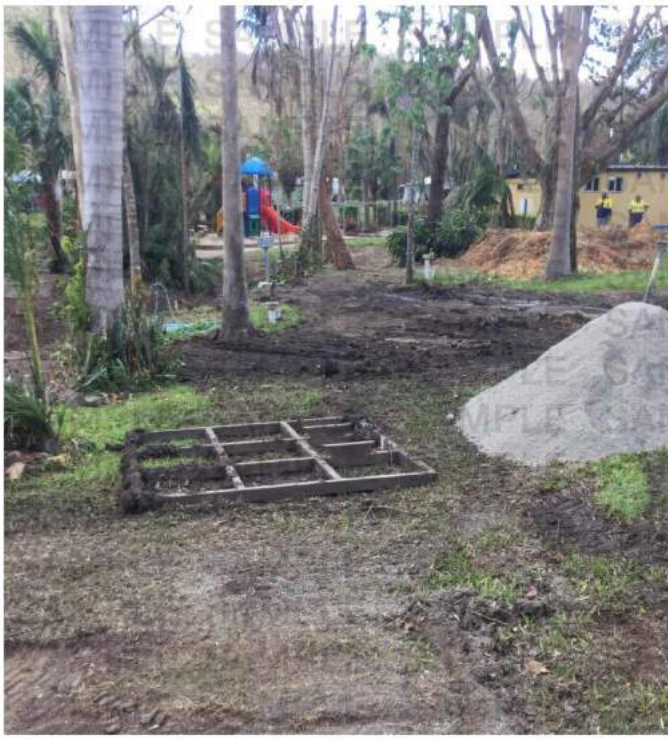
Photo 9 Repairs to grounds and tree damage carried to make safe.

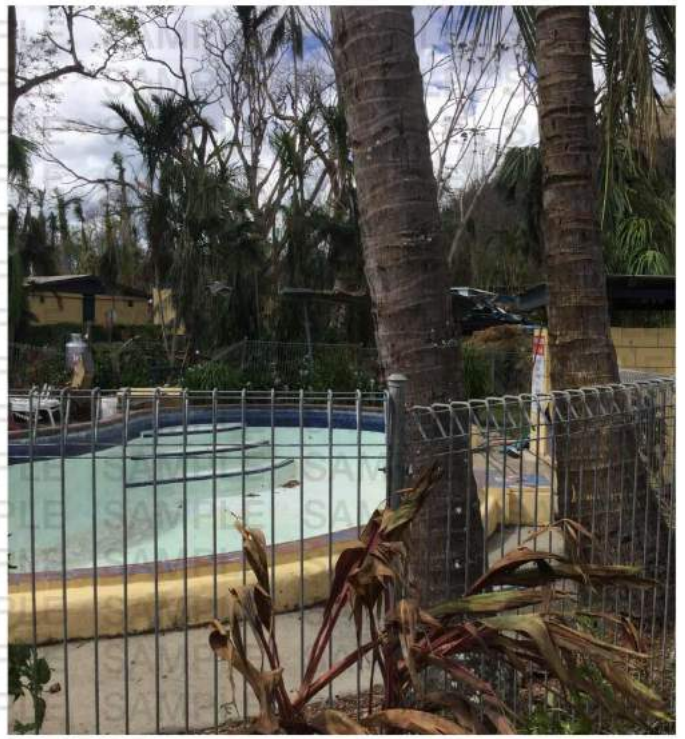
Photo 10 Tree damage to pool fencing, pool has been emptied to make safe.

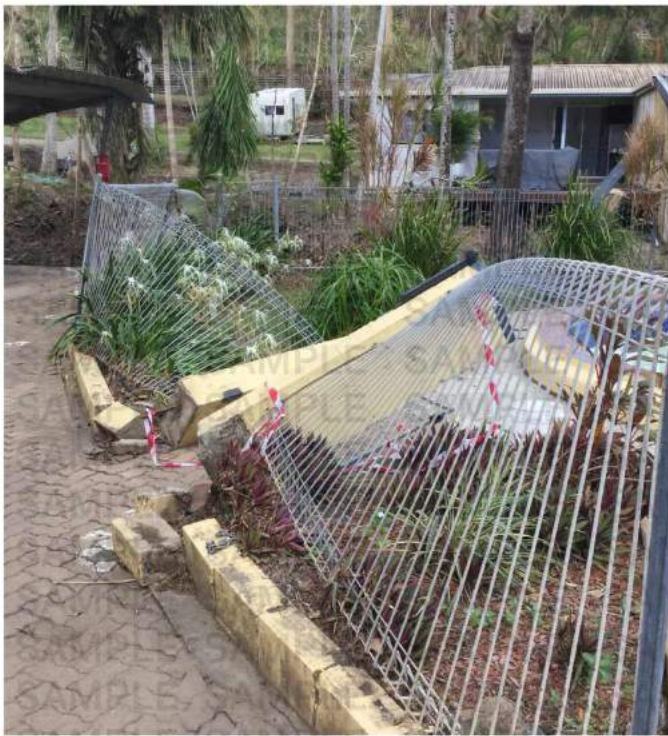
Photo 11 Pool gate support piers (Masonry) damaged and collapsed under tree damage.

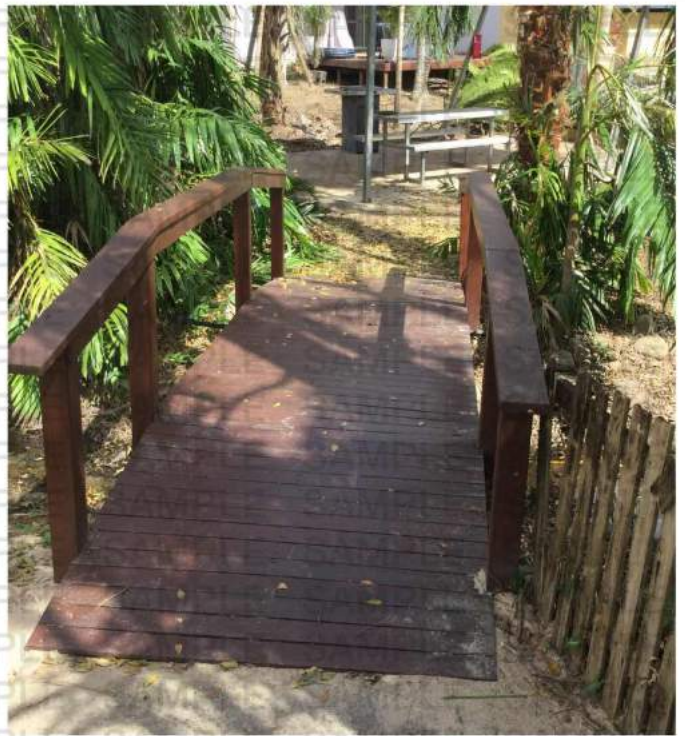
Photo 12 Minor repairs to timber bridge as a result of tree damage.

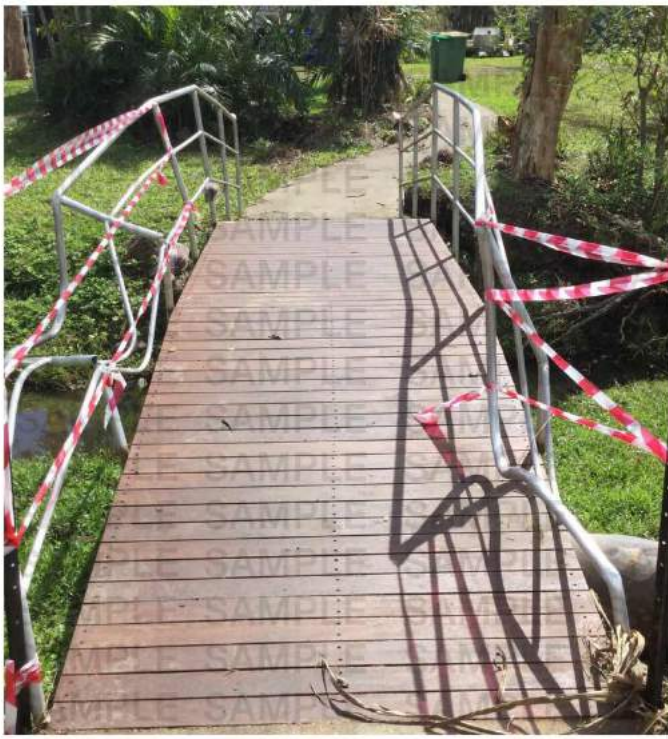
Photo 13 Tree damage to Alluminium guardrails of bridge.

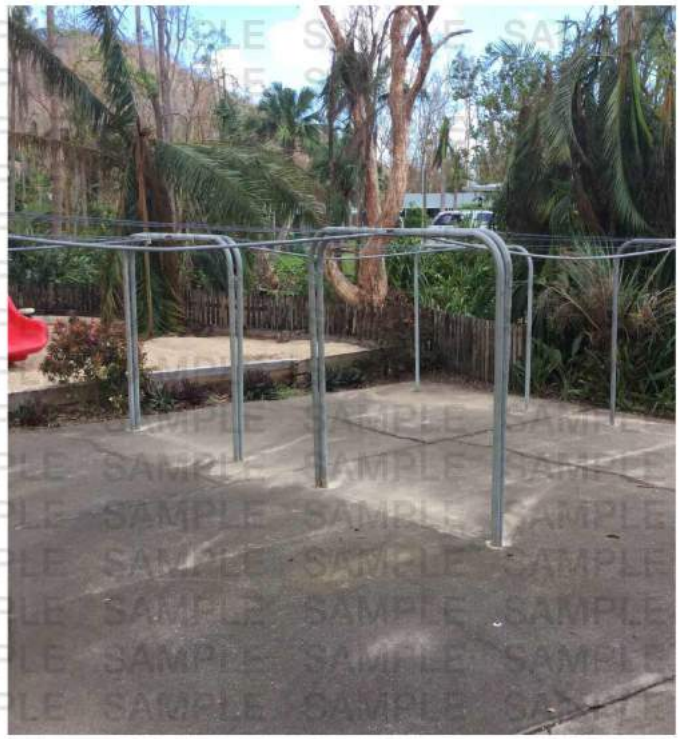
Photo 14 Minor damage to public clothlines, considered repairable.

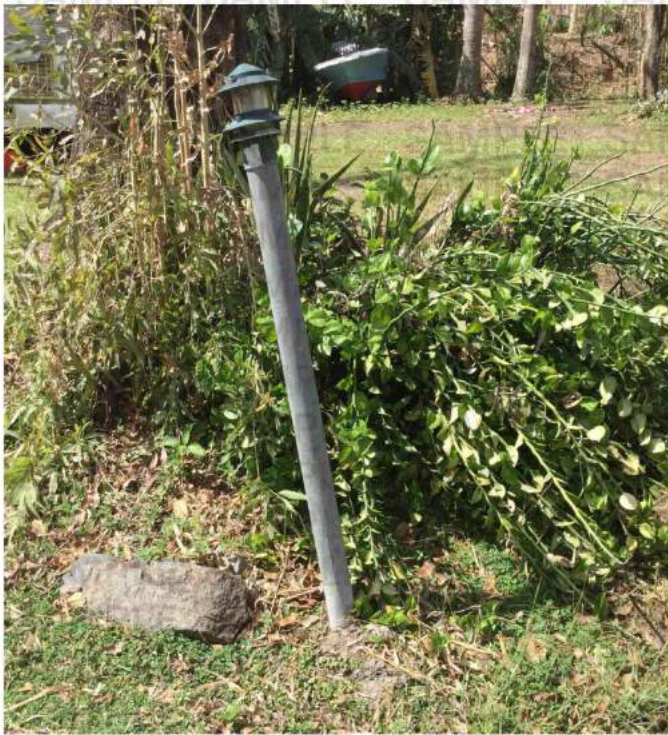
Photo 15 Security lighting damage to rear access road.

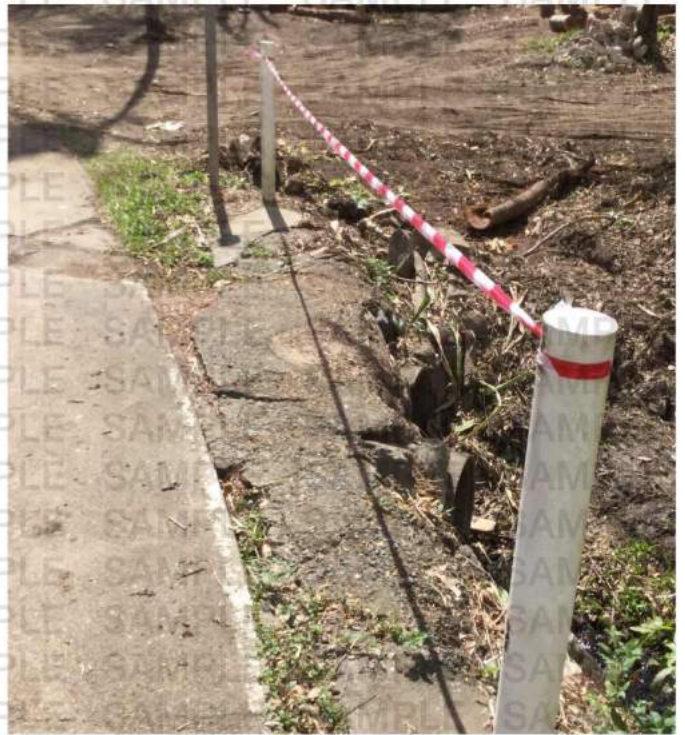
Photo 16 Timber guard rail damage to rear causeway.

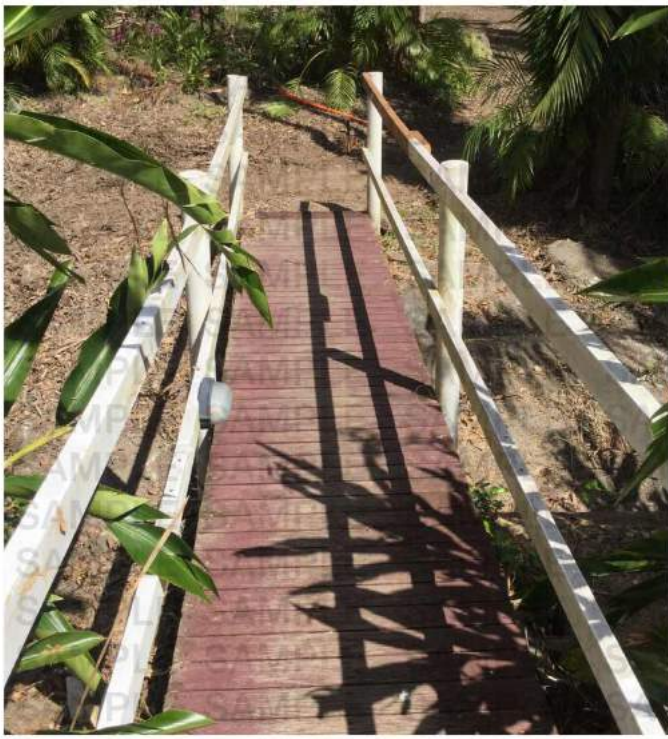
Photo 17 Temporary repairs to timber guard rails performed.

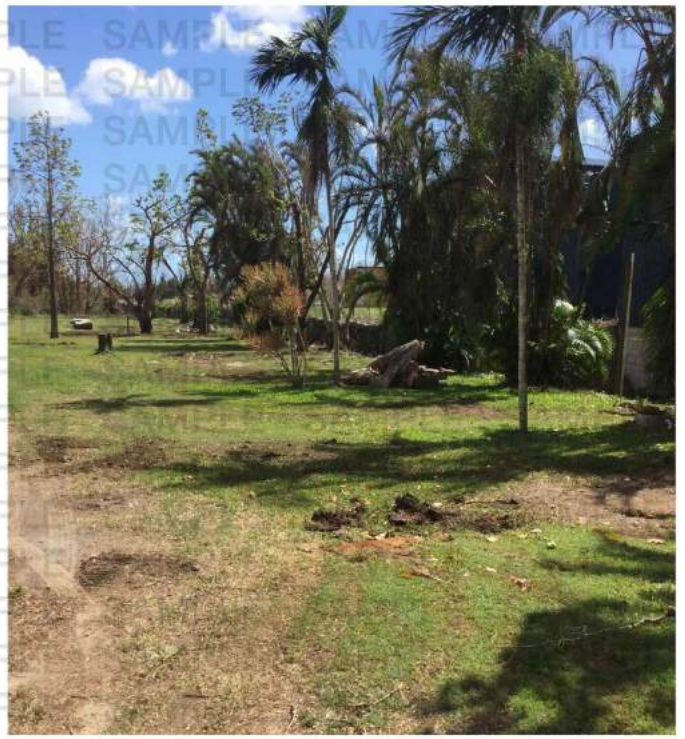
Photo 18 Various extensive tree damage, site made safe along rear boundary.

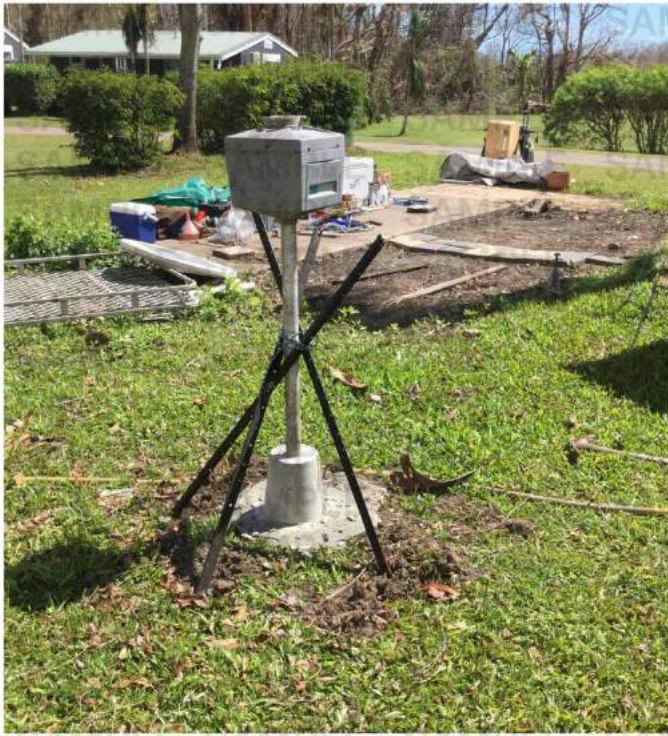
Photo 19 Various repairs to camp Powered sites performed to make safe by trades.

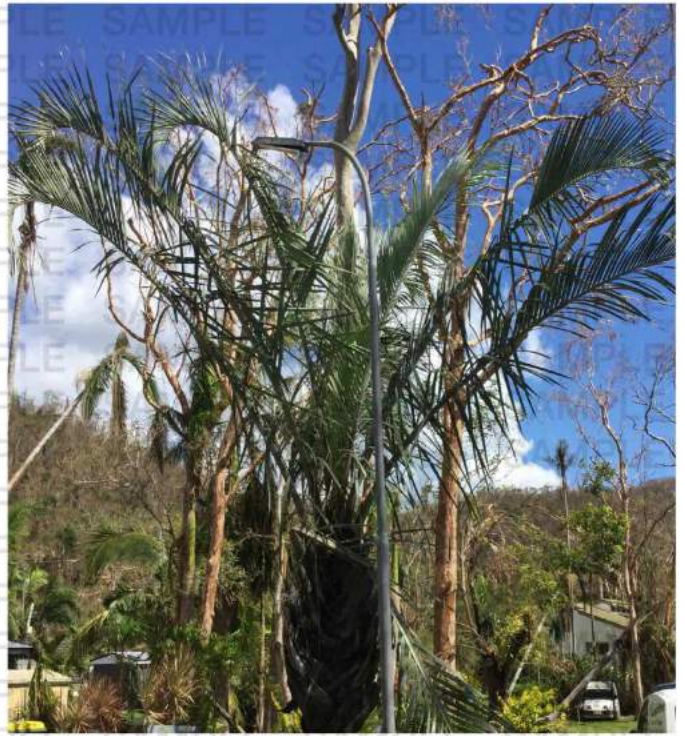
Photo 20 Various damage street lighting present.

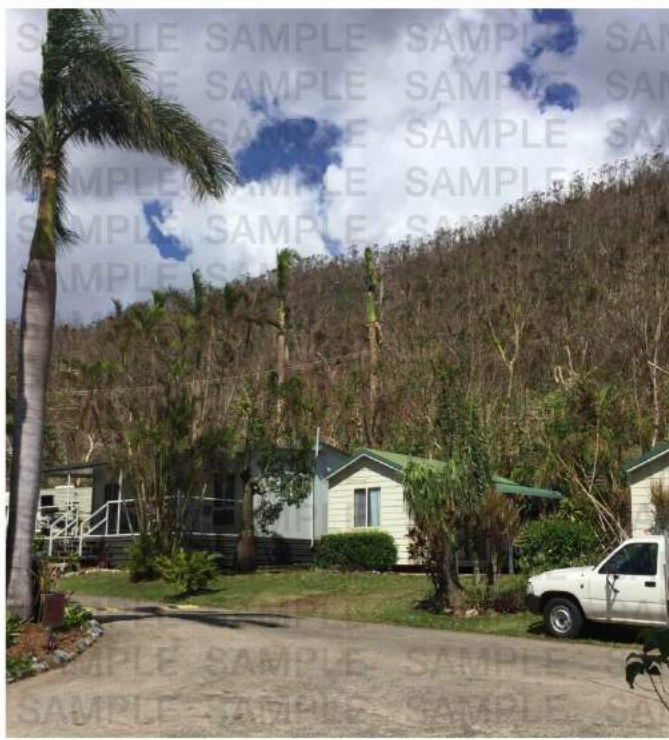
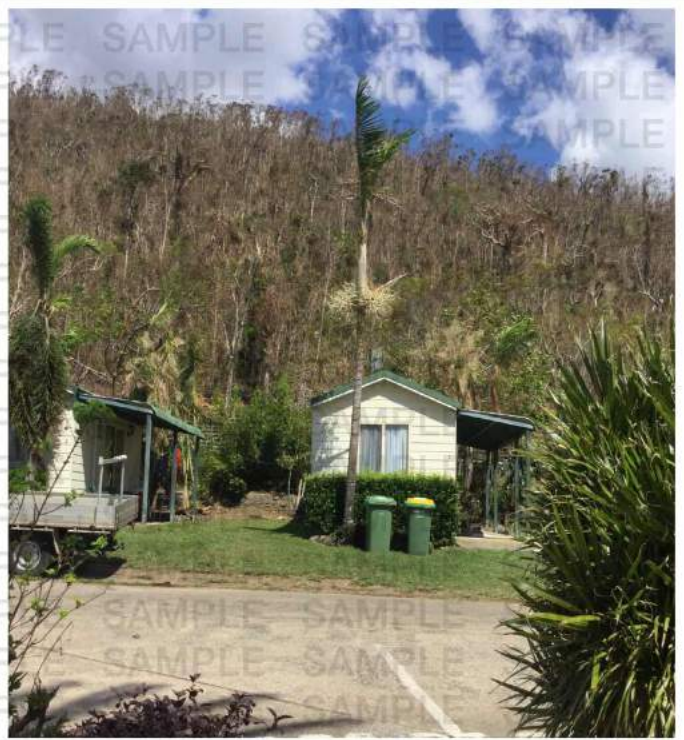
Photo 22

Photo 21 Street facing villas have recieved inundation due to extreme runoff from

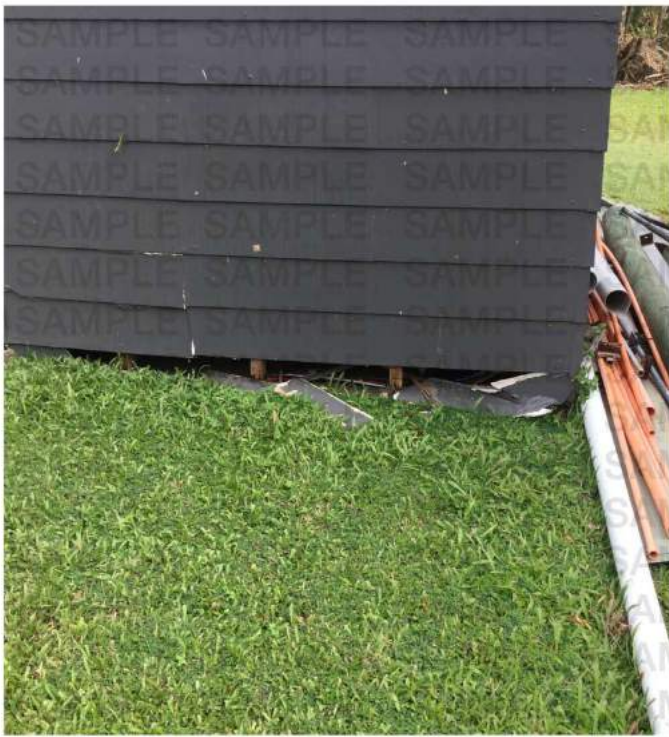
Photo 23 External cladding damage to Switchboard room. ACM to be verified.

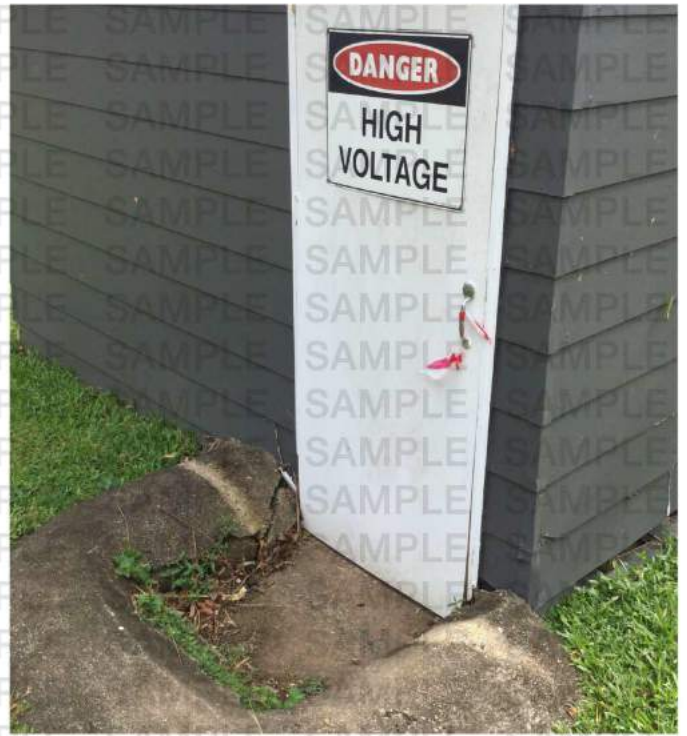
Photo 24 Evidence of uplift on Switchboard room visible at bottom plate failure.

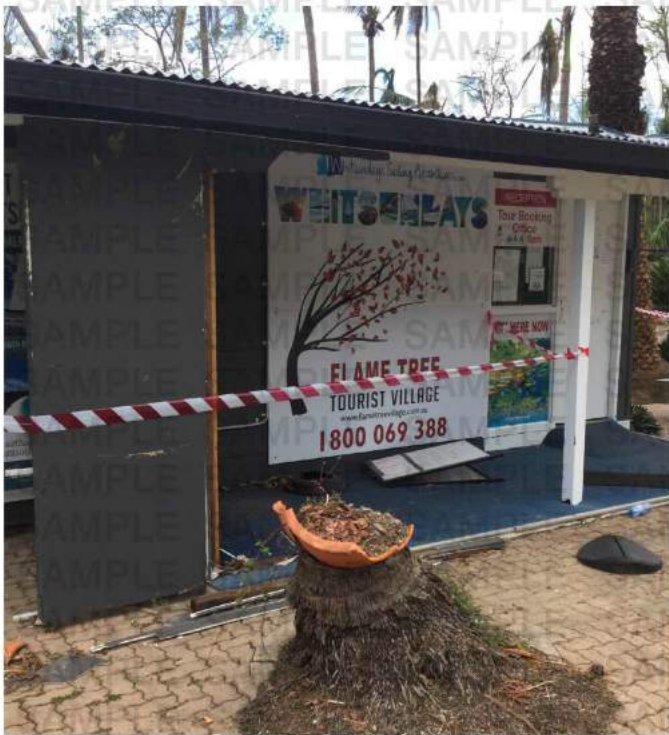
Photo 25 Main Tourism office daaged by water inundation to timber floor. Retoration and make safe required due to moisture effects on flooring.

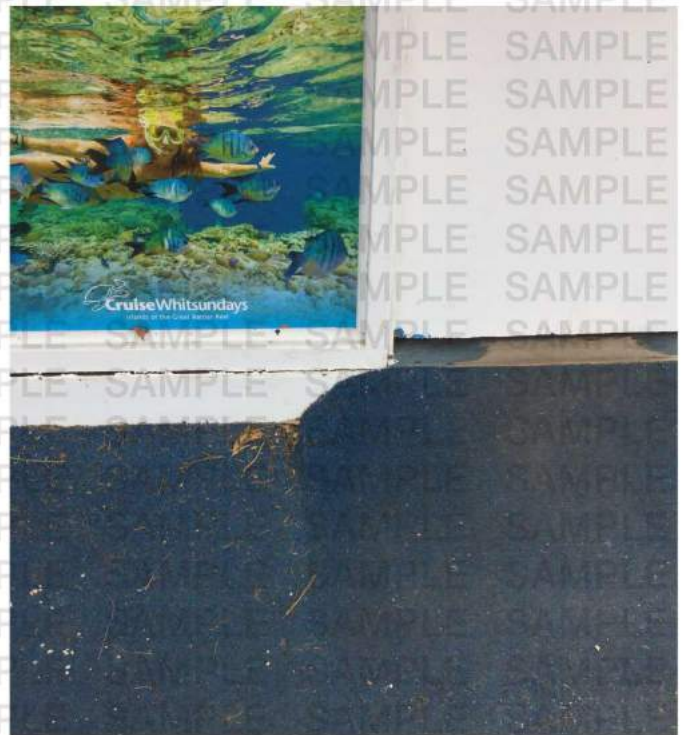
Photo 26 Uplift of external wall adjacent entry visible. ACM is to be verified.

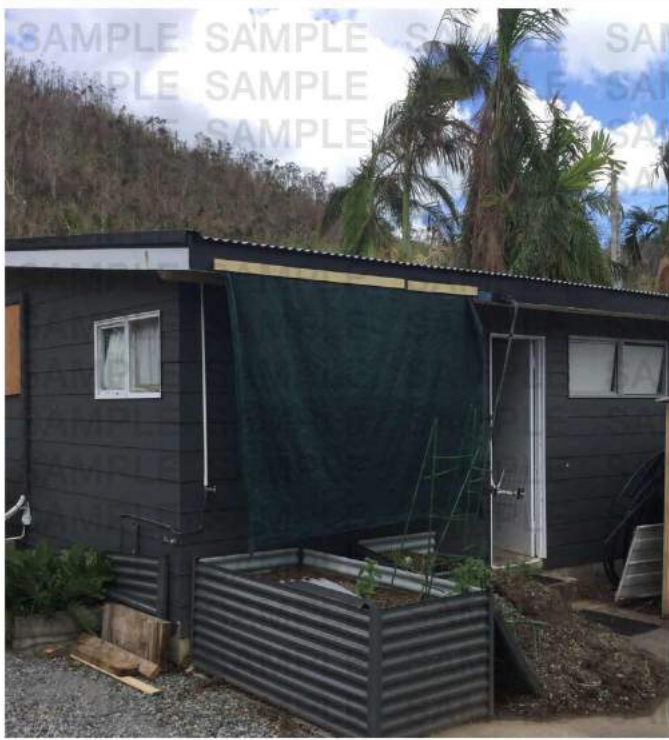
Photo 27 Rear of Office building gutter damage & floor inundation.

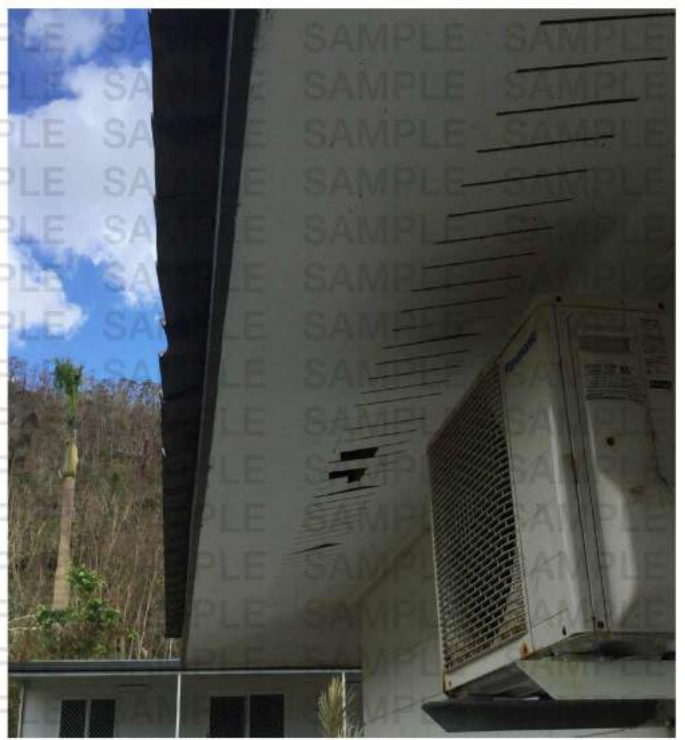
Photo 28 Damaged vented soffit sheeting to main caretakers residence at rear. Nil gutters to roof from existing.

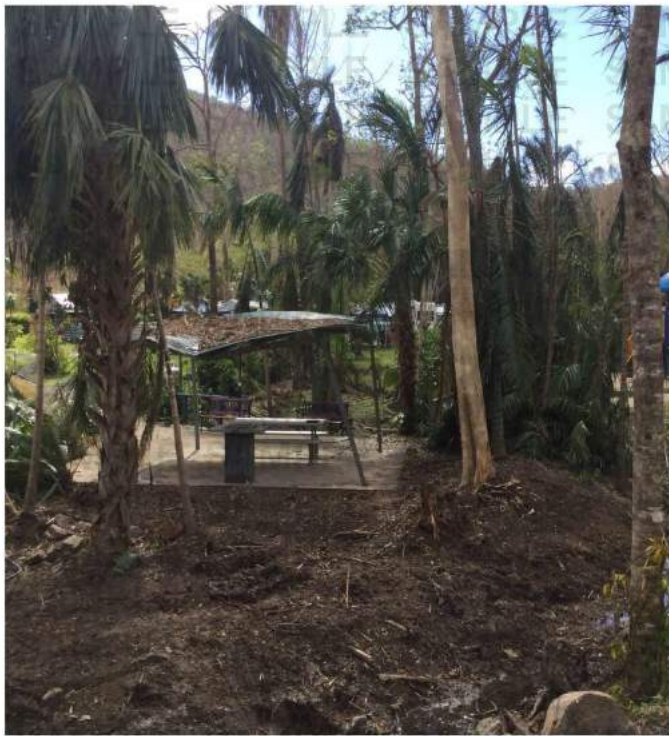
Photo 29 Tree damaged BBQ shelter adjacent to Pool area.

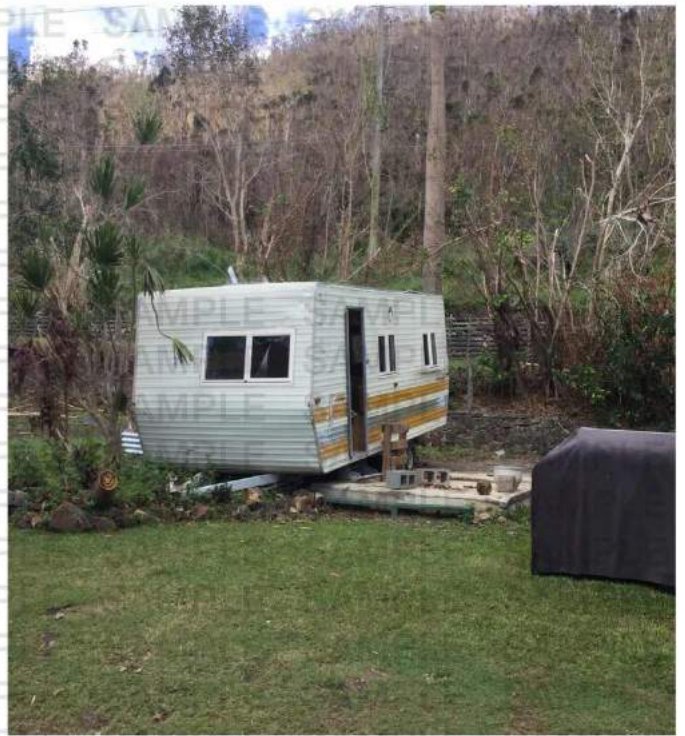
Photo 30 Tree damaged onsite caravan beyond economical repair.

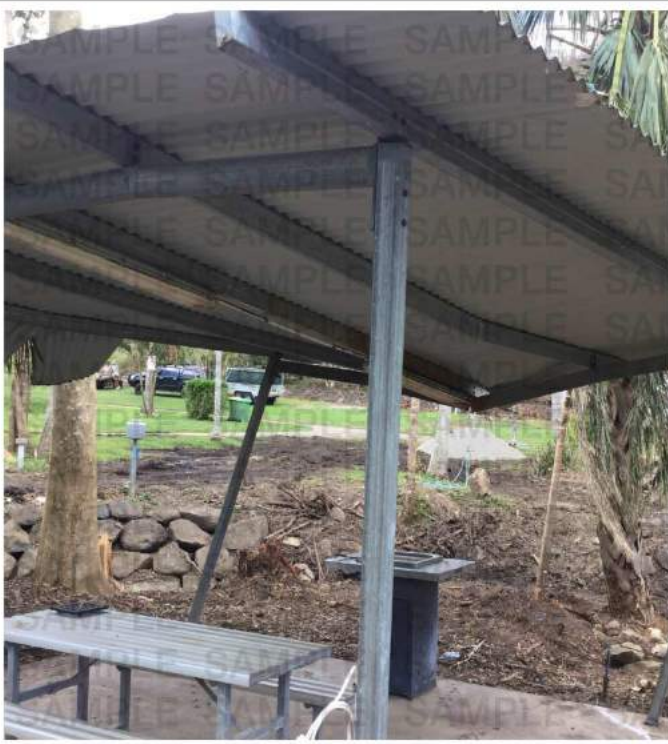
Photo 31 BBQ Shelter suffered tree damage, beyond repair.

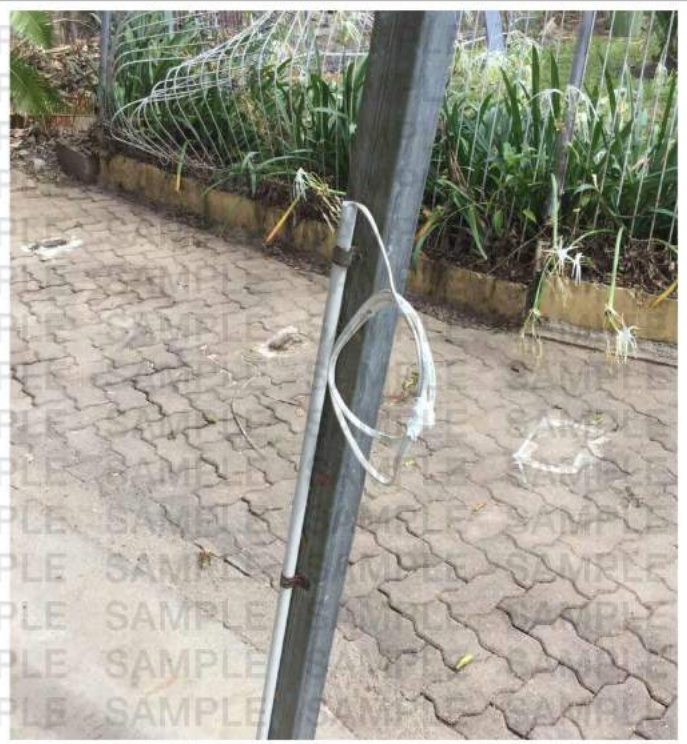
Photo 32 BBQ Electrical to be verified for make safe.

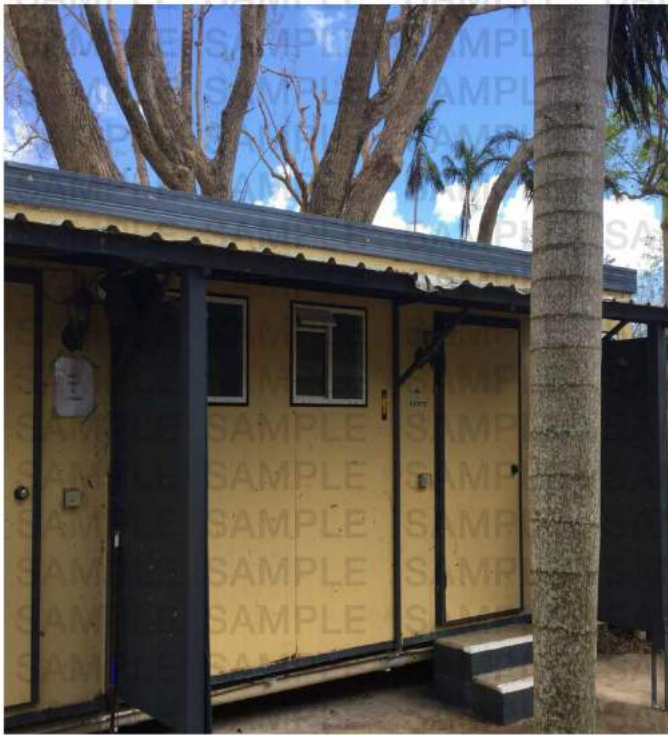
Photo 33 Roof damage to amenities awning .

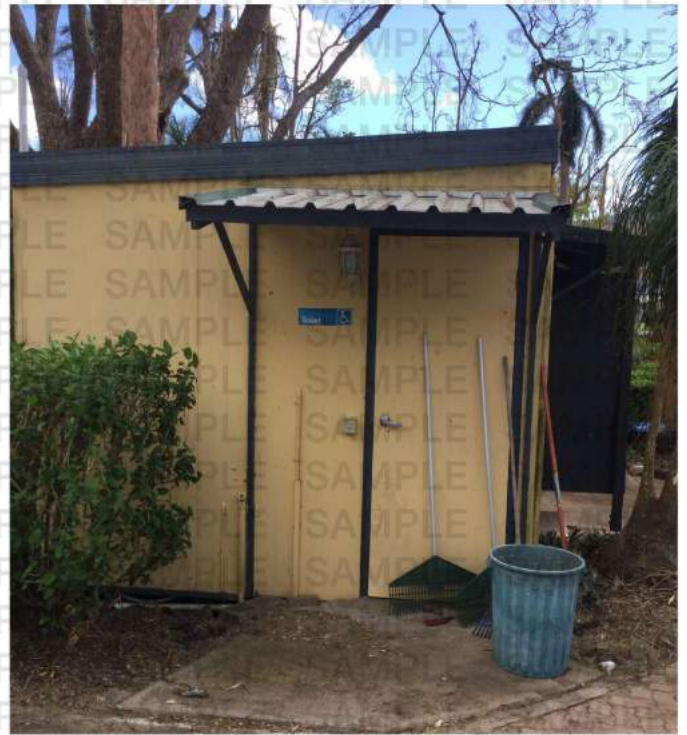
Photo 34 Accessible WC considered an essential building, various roof repairs required.

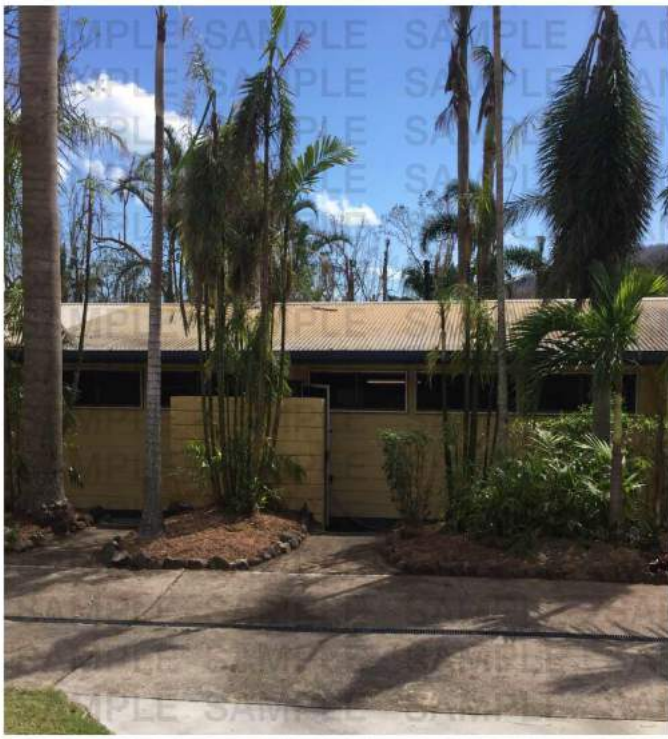
Photo 35 Main amenities building various minor repairs to roof required.

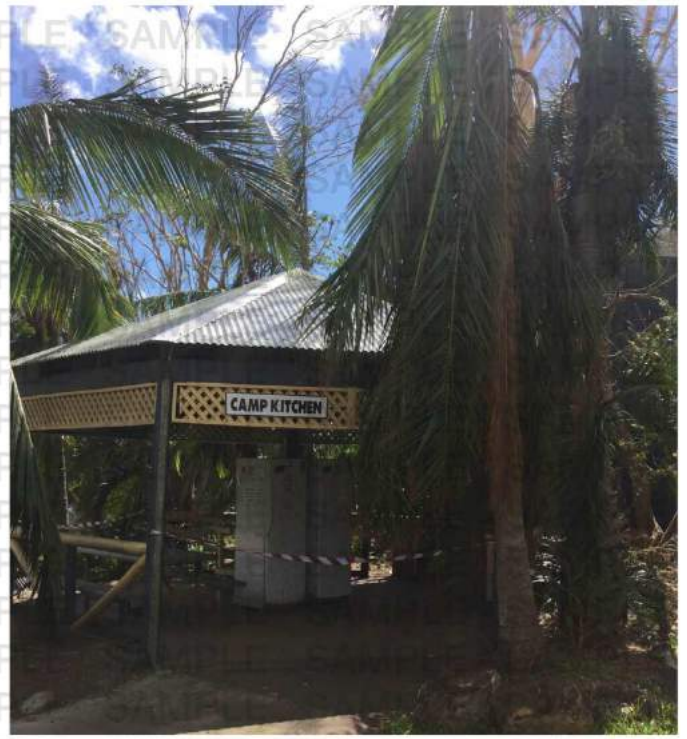
Photo 36 External camp kitchen hexagonal shaped roof, general sound, structure has racked out of plumb, reposition true and replace poles and rails as required.

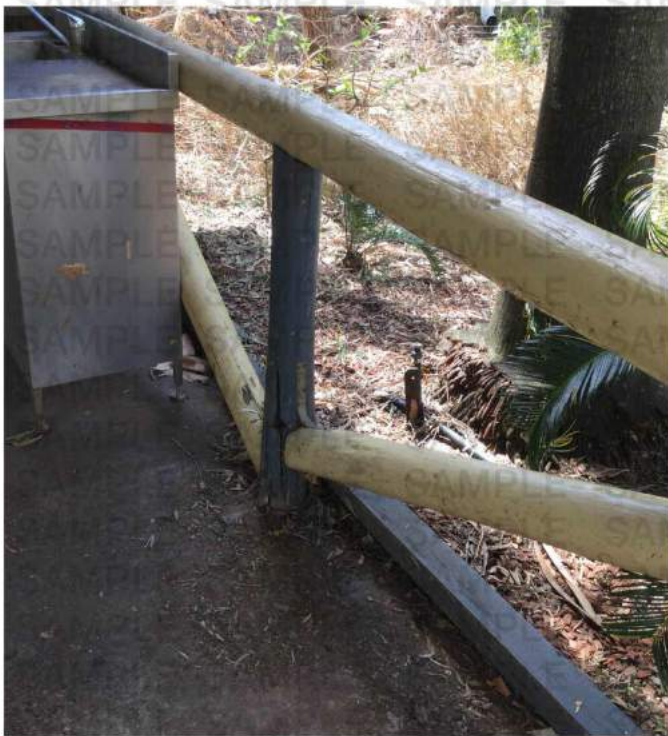
Photo 37 Various broken log rails present from tree damage, repair & replace as required to Camp Kitchen.

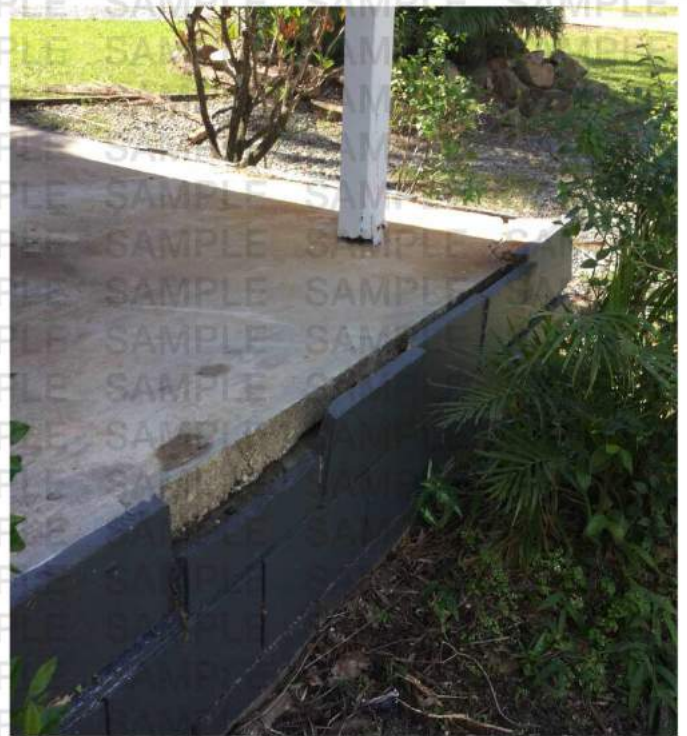
Photo 38 Cabin 1 Suffered uplift to ront awaing patio roof, lifting the slab from the block base

BUILDING EXTERIOR	MAJ	MIN	AU	NF	NA	NI	PHOTO YES OR NO	COMMENTS
FOUNDATIONS / FOOTINGS	✓							Cabin 1 suffered uplift of the front LH corner of the front patio. refer to photos below. Provide repairs with new piers and H brackets.
MASONRY WALLS	✓							Dislocated masonry block base to cabin 1
EXTERNAL CLADDING	✓							Switchboard external cladding & Office building suffered damage to cladding in the main. Refer to specific building in photos below.
EXTERNAL DOORS	✓							Switchboard building door requires replacement. Private laundry shed doors damaged.
WINDOWS & AWNINGS		✓						Inundation has occurred in the villas causing moisture damage.
SOFFITS		✓						Various soffit damage visible to the Office building & Caretakers building.
FASCIAS		✓						Minor damage present.
GUTTERS / DOWNPIPES	✓							Various repairs & replacement required.
ROOF	✓							Tree damaged components to specific buildings as noted.

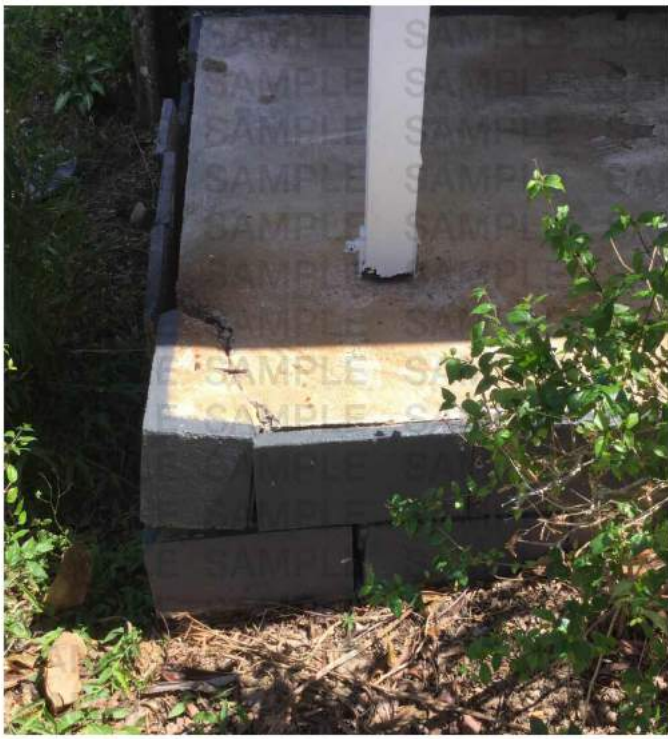
Photo 39 Evidence of uplift on the front LH corner of Cabin 1

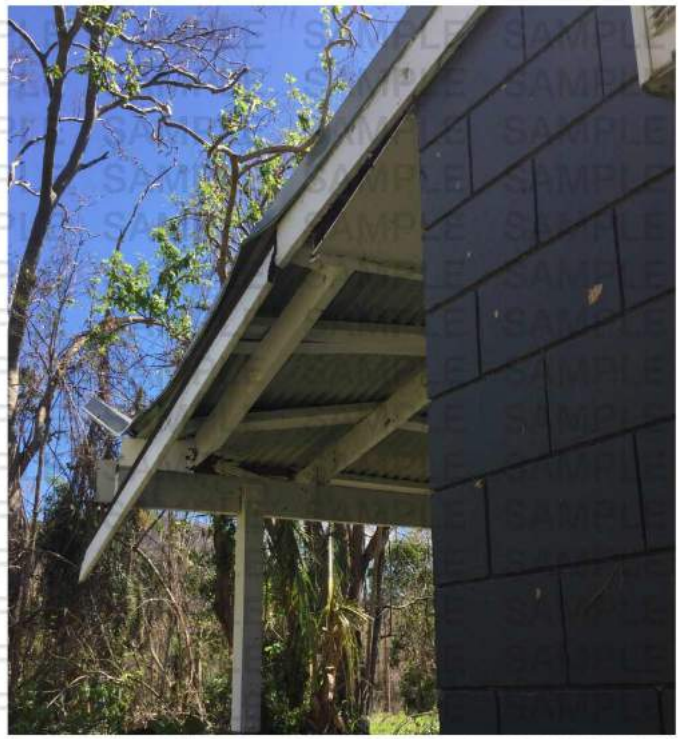
Photo 40 Tree damage of Cabin 1 rear patio roof. Repair & replace effected timber rafters and framing to rear LH corner.

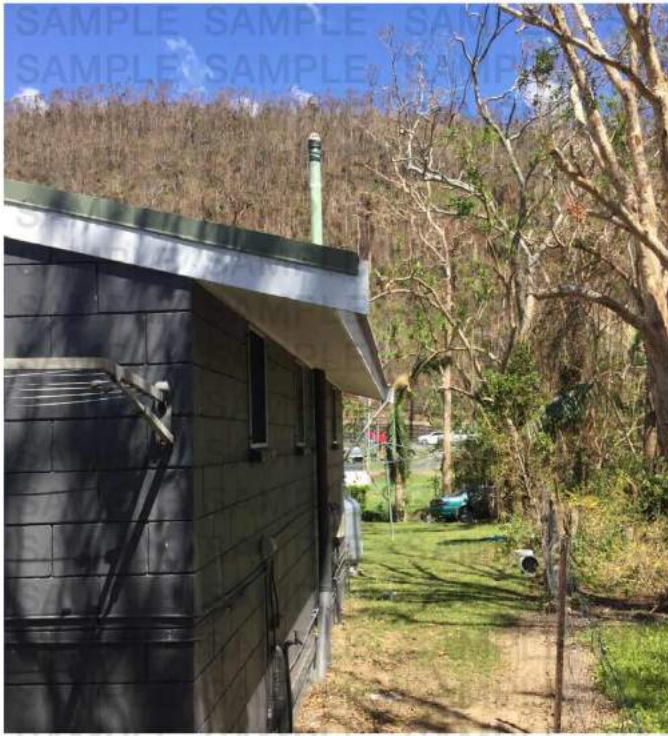
Photo 41 Rear of Cabins existing without gutters. Noted.

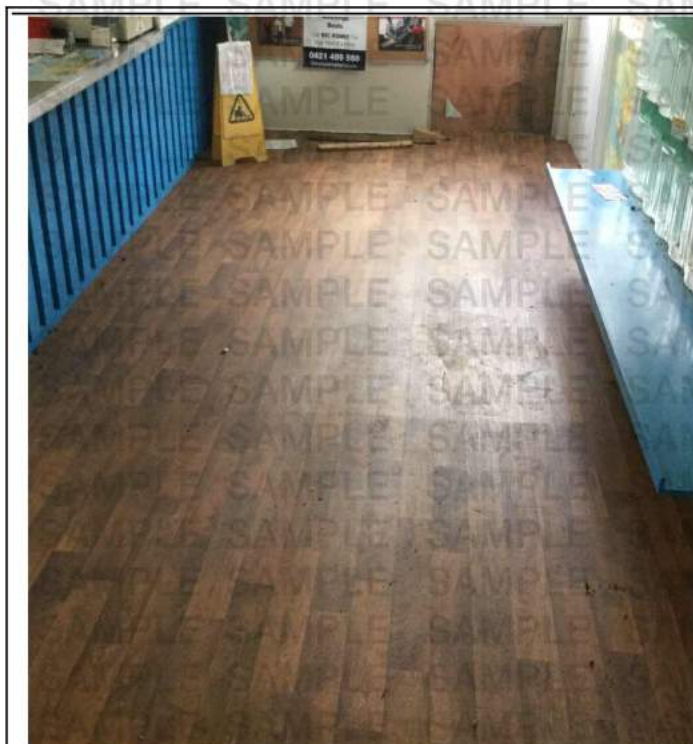
Photoss42 Office building, Floor inundation, vinyl flooring moisture entrapped underneath.

INTERIOR SUB-FLOOR/FRAME	MAJ	MIN	AU	NF	NA	NI	PHOTO YES OR NO	COMMENTS
DRAINAGE / VENTILATION	✓		✓					Office building inundated floor. Restore and remove damaged floorcoverings and dry out cavities. Unable to inspect office sub-floor due to restricted height above ground.
CONCRETE SLAB	✓							Rear office slab requires removal of floorcoverings.
SUPPORT POSTS	✓							Office building & Cabin 1 damage present. Refer to photos below for specifics.
BEARERS / JOISTS	✓		✓					Moisture laden Office floor exists, unable to fully assess condition until exposed
PLUMBING / DRAINS						✓		
BRACING	✓							Camp Kitchen building racked due to high winds.
TIE-DOWNS	✓							Upgrade defective tie-down to Cabin 1 & Office Building as required.
DEBRIS / MATERIALS	✓							Significant tree damage & debris has been cleared away during inspection.

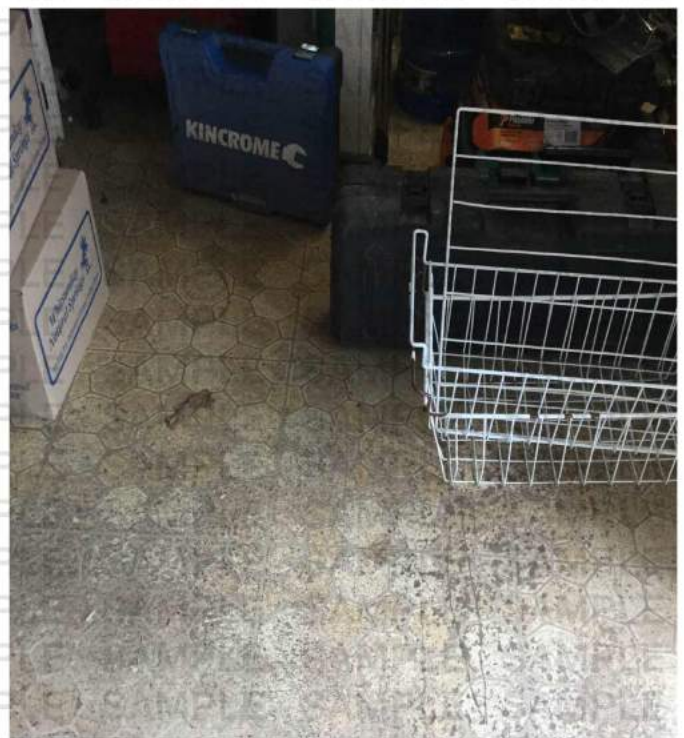
Photo 43 Office building rear slab moisture underneath vinyl flooring. ACM Materials to be verified.

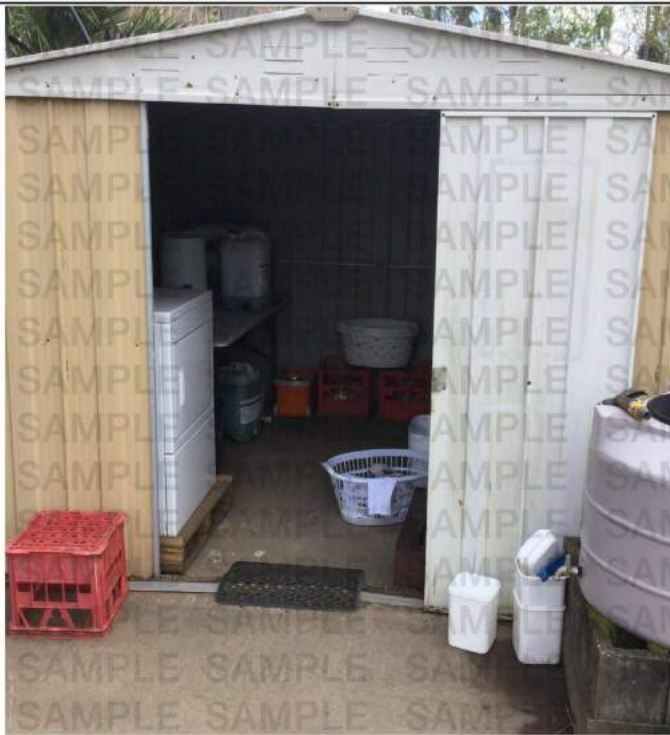
Photos44 Privatelaudry shed damaged in doors and wall sections.
