## RESIDENTIAL DILAPIDATION REPORT

CLIENT: Flametrees Tourist Village

2955 Shute Harbour Drive Airlie Beach QLD 4802

Detail damage following TC Debbie

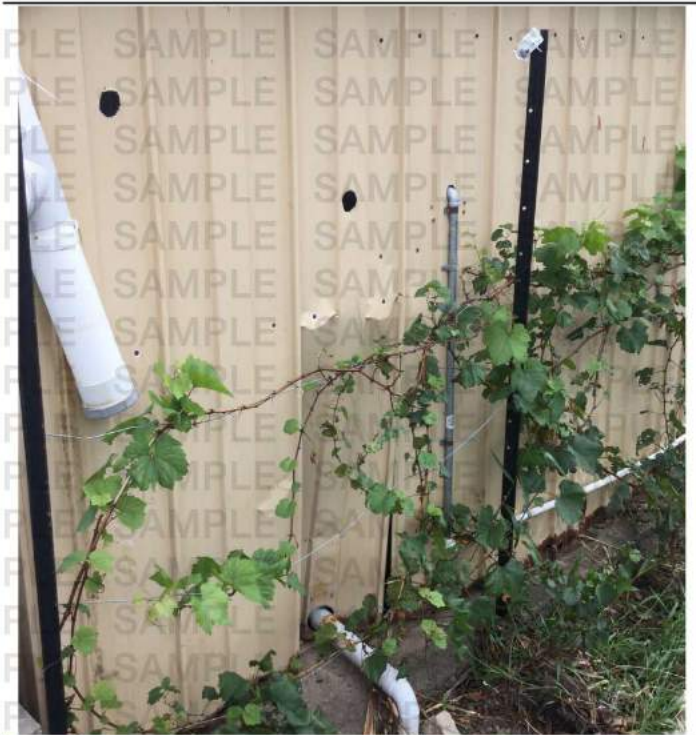
Photo 45 Damaged laundry shed wall panels.
